SLOPE STABILITY ANALYSIS OF BURIGANGA RIVER BANK

Abstract. *The paper aims to evaluate the stability of a particular section of the Buriganga River embankment, which is an economically significant river in Bangladesh. The study involved collecting soil samples from the embankment to determine its index properties, grain size distribution, organic matter content, and shear strength parameters. Laboratory tests, including direct shear and consolidated drained shear tests, were conducted with varying water content and normal load to determine the cohesion and angle of internal friction for both disturbed and undisturbed soil samples. Using XSTABL software, slope stability analysis was performed with a 1:1.5 slope based on the soil investigation results. The maximum factor of safety was found to be 1.548 for the undisturbed soil sample and 0.82 for the disturbed soil sample. The study showed that increasing soil cohesion significantly increases stability.*

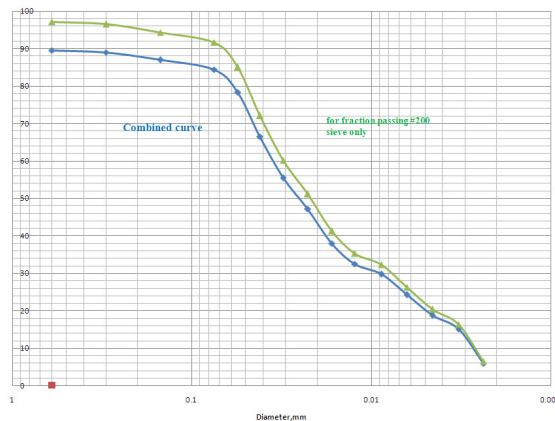
Fig. 2: Hydrometer analysis.

The test showed that, 92.15% of the soil particles are finer than #200 sieve. Therefore, hydrometer analysis was performed on the soil sample instead of ordinary sieve analysis. Fig. 2 shows the results of hydrometer analysis.

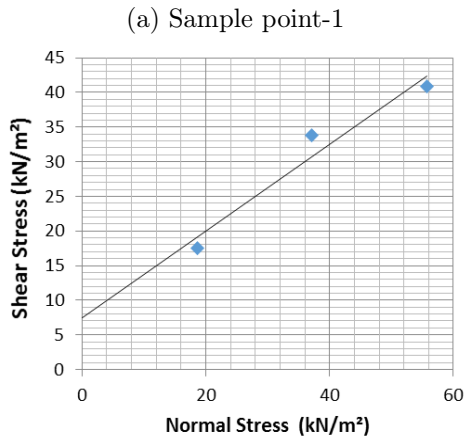
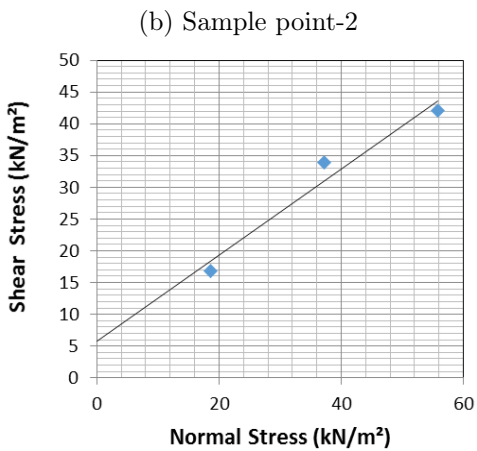
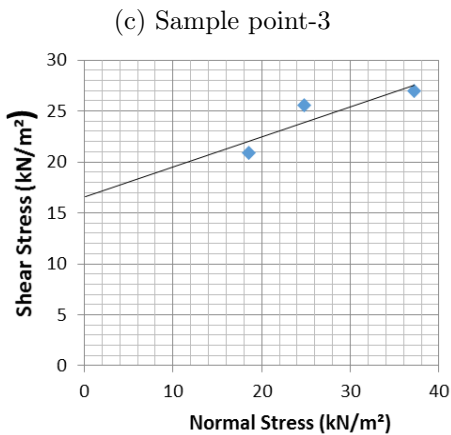
Fig. 3: Hydrometer analysis.

Undisturbed samples were tested to see how their strength changes with the change of location along the slope. Samples collected from three different locations were tested. Sample point-1 and point-2 were situated at the upper portion of the slope. Sample point-3 was situated near the river flow. Results are showed in Fig. 3.

Tab. 2: Strength Parameters of Undisturbed Sample.

Location	Cohesion, C (kN/m ²)	Angle of internal friction, φ (°)
Collection point-1	7.37	32.15°
Collection point-2	5.67	34.21°
Collection point-3	16.55	16.44°

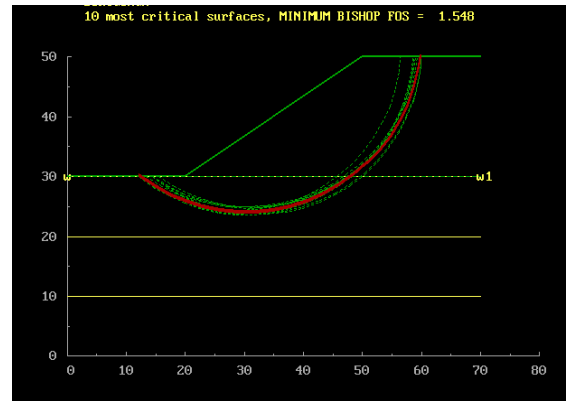
is $10 \times 10 = 100$. After all the necessary data input for the embankment section of Buriganga total 10 most critical surfaces and the minimum

Factor of Safety have been found and shown in Fig. 8 (only for undisturbed sample - 3).

Fig. 8: Display of the 10 most critical surfaces & the minimum factor of safety for Borehole 3 (undisturbed soil).

To analyze slope stability by the XSTABL program certain steps have to be followed. The geometry of the slope, soil data for surface and subsurface has been provided. In the program the number of initiation points of circular surfaces is selected as 10. From each initiation point 10 number of surfaces are to be generated and as a result total number of surfaces generated

Factor of safety for other soil sample has been compiled in Table 4. Slope stability has been done maintaining 1:1.5 slope. The maximum factor of safety has been found 1.548 for undisturbed and 0.82 for disturbed soil sample. From this analysis it has been noticed that the soil stability increases with the increase of cohesion of soil.
